Landform mapping of Waikereru Ecosanctuary

Authors: Mike Marden & Anne Seymour 2022

Goal: Produce a GIS-based map of landform units present at Waikereru Ecosanctuary.

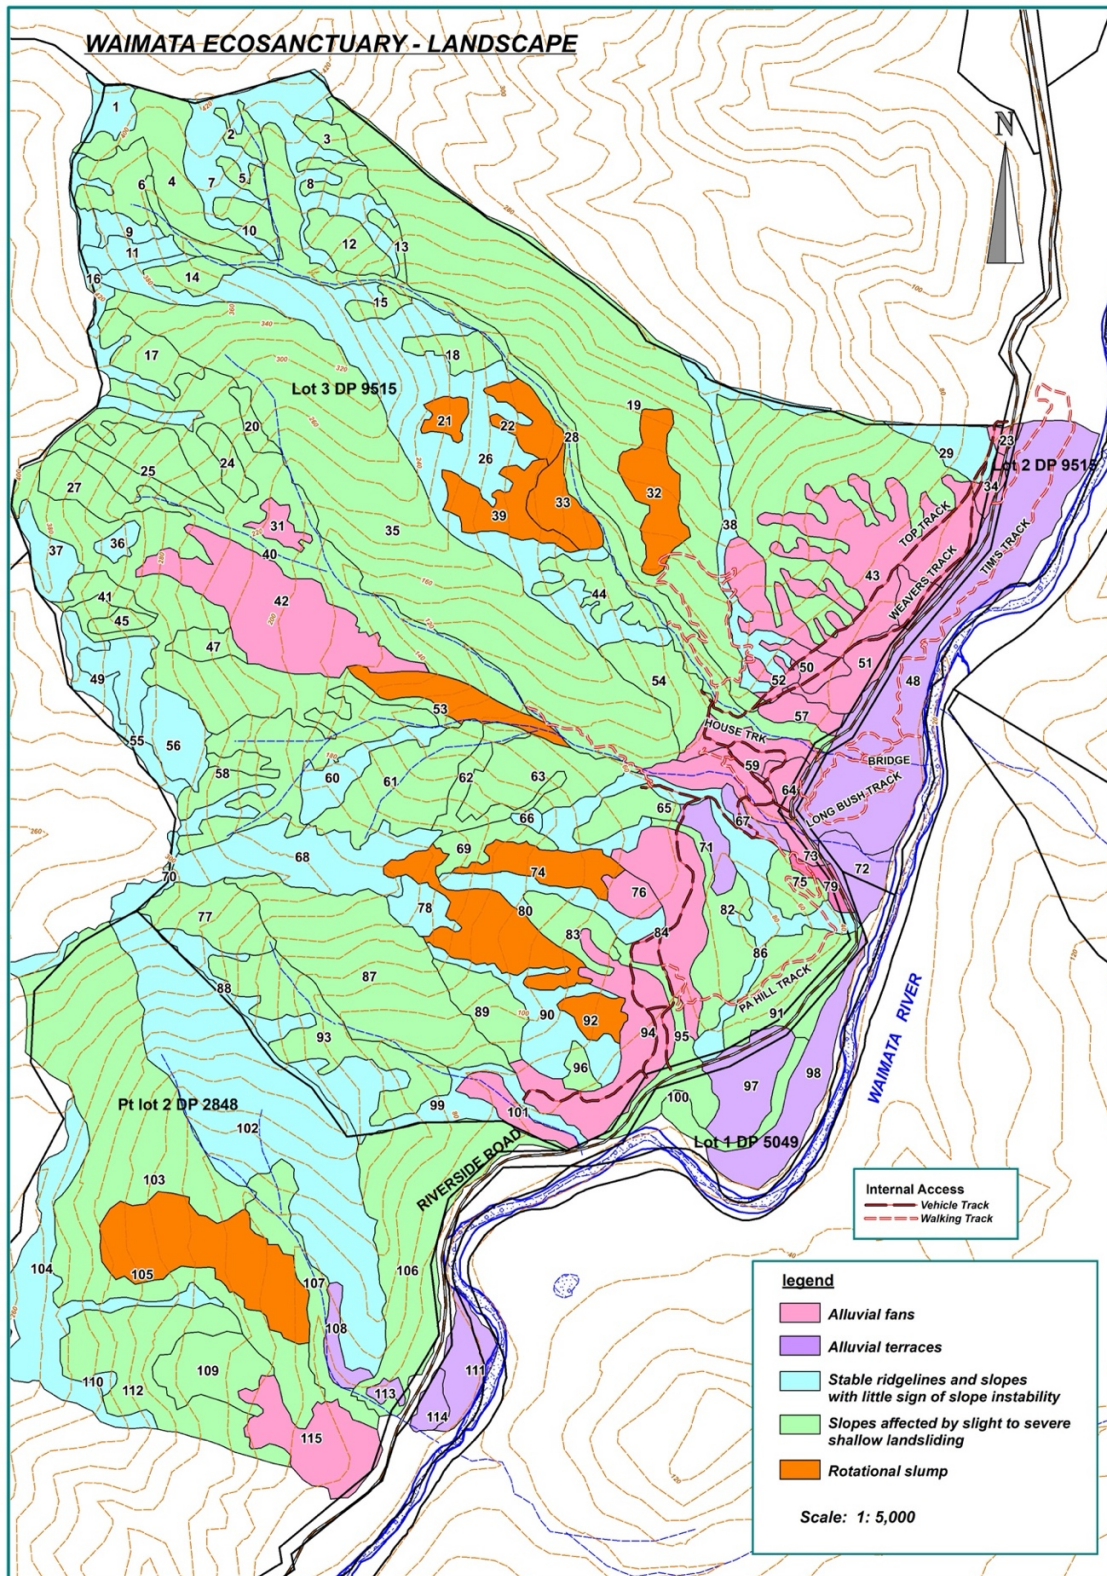
Legend for landscape units-Waimata ecosanctuary

ST- Stable ridgelines and old rotational slumps. Covered materials include layered tephra (volcanic and ash) of variable thickness plus forest topsoil. The coverbeds are in places likely to be quite thick and in-tact (i.e., undisturbed).

SL-Shallow landslide scars. Predominantly located on steeper valley slopes. Landsliding generally results in the stripping of all coverbed materials to expose the underlying bedrock lithologies. Present-day coverbed materials are likely to have been dislodged from the slopes above the original landslide scar and hence will be thin and skeletal (i.e., a high percentage of angular clasts of sandstone and siltstone mixed with minor finer-grained sediment). Vestiges of preserved volcanic tephra are possible but will be small in aerial extent.

SLU-Rotational slump. Deeper-seated failures where the displaced material is displaced *en-masse* but has remained largely in-tact. Some of the slumps likely occurred before European settlement, while others have failed in more recent times. The surface of slumped blocks, though inclined, is considerably less steep than the surrounding hill slopes. Upon the body of the slumped mass, volcanic ash and pumice beds are likely present, though possibly buried by debris generated during more recent storm-initiated shallow landslide failures triggered on the slopes above and surrounding the original slump, accumulating on the surface of the original slump block.

F-Alluvial fan. Sloping landscape units located at the base of steep slopes. Fans represent zones of accumulation of material displaced by slumping and shallow landslides. Coverbed materials consist of thoroughly mixed landslide debris. Angular bedrock clasts predominate, possibly with some evidence of water-sorting during deposition, thus some stratification representing multiple episodes of landsliding and deposition during past storm events may be present. Over time, the drainage channels have incised in response to tectonic uplift, thus the toe slopes of several of the older fans have been truncated, including those fans located at the base of slopes flanking the true right bank of the Waimata River.

T-Alluvial terrace. Best preserved along the true right bank of the Waimata River where in past times this river has truncated alluvial fans emanating from the side tributaries draining the Ecosanctuary. The covered material comprises fine-grained alluvial sand, silt and clay deposited during successive floods. In places, particularly at the confluence of the side streams and the Waimata River, coarser-grained material (e.g., silt and sandstone clasts), excavated and transported from existing alluvial fan deposits present within the side streams, will also be present.

Method: Landform units were identified on aerial photography flown in 1953 (SN 818, Run 2161, prints 16 & 17). Using a mirror stereoscope and a mapping pen, each unit was delineated onto the photographic prints as a 'closed' polygon. Each polygon was then digitized from registered images of the photographs to provide a GIS-based data set for use in MAPINFO (Map 1). In total, 115 polygons were mapped, and each was assigned a discreet number. An accompanying spreadsheet lists each polygon for which a measured area (ha) and Land Use Capability (LUC) class is provided. The LUC units together with contours and parcel boundaries are shown on Map 2 which is an aerial view of the ecosanctuary flown in 2017. Both maps are at a scale of 1:5000. Descriptors for the LUC units are provided in Table 1.

Of the 5 landform units mapped across an area of 156.48 ha, shallow landslides initiated during multiple storm events since European occupation have impacted 54% (85.04 ha) of the steepest slopes while stable ridges and old rotational slumps little affected by more recent failures comprise 22% (34.45 ha). Rotational slumps displaying more recent signs of slope instability comprise 6% (9.8 ha) while alluvial fans make up 11% (16.58 ha) and alluvial fans 7% (10.61 ha) of the ecosanctuary area.
