# Ecological Monitoring of three Tairāwhiti estuaries: Kaitawa Estuary, Tūranganui Estuary and Te Wherowhero Lagoon

August 2025

Isabella Clere

Coastal and Marine Scientist, Gisborne District Council, Gisborne, New Zealand

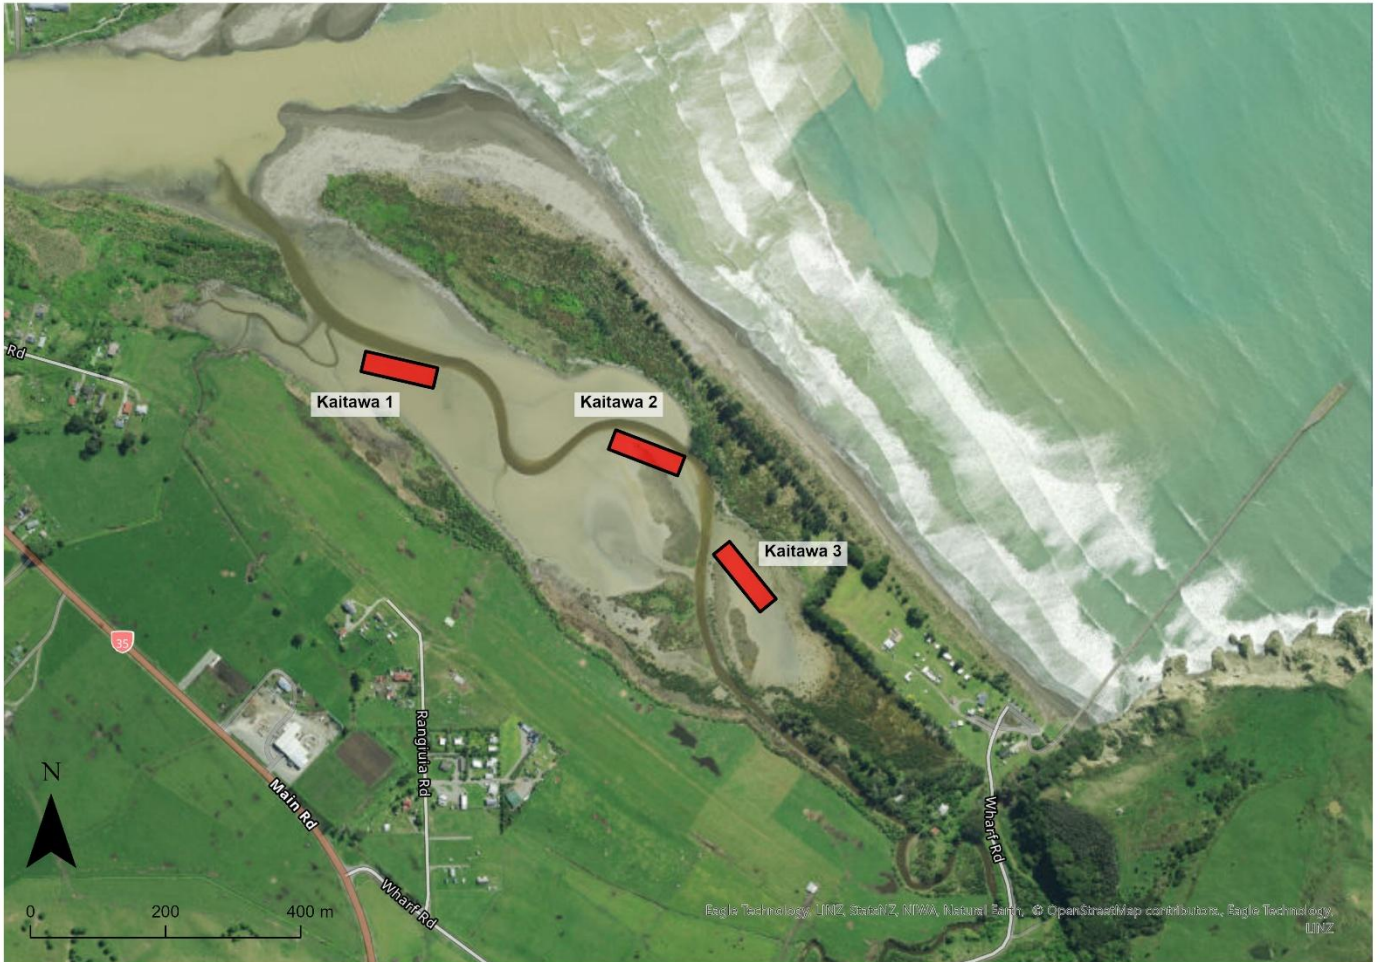
Figure 1. Map of Kaitawa Estuary.

Three representative sites were surveyed at Kaitawa Estuary (Figure 1) and were established at suitable benthic habitats. Kaitawa 1 was in the northern end of the estuary, close to the mouth, Kaitawa 2 was located in the middle of the estuary and Kaitawa 3 was positioned at the southern/upper end of the estuary near the Kaitawa Stream inlet. Each survey site measured 60m x 30m and was split into nine plots, each measuring 20m x 10m, to achieve nine replicates per location. The long edge of each site was positioned parallel to the water's edge. Site GPS coordinates can be found in Appendix 1.

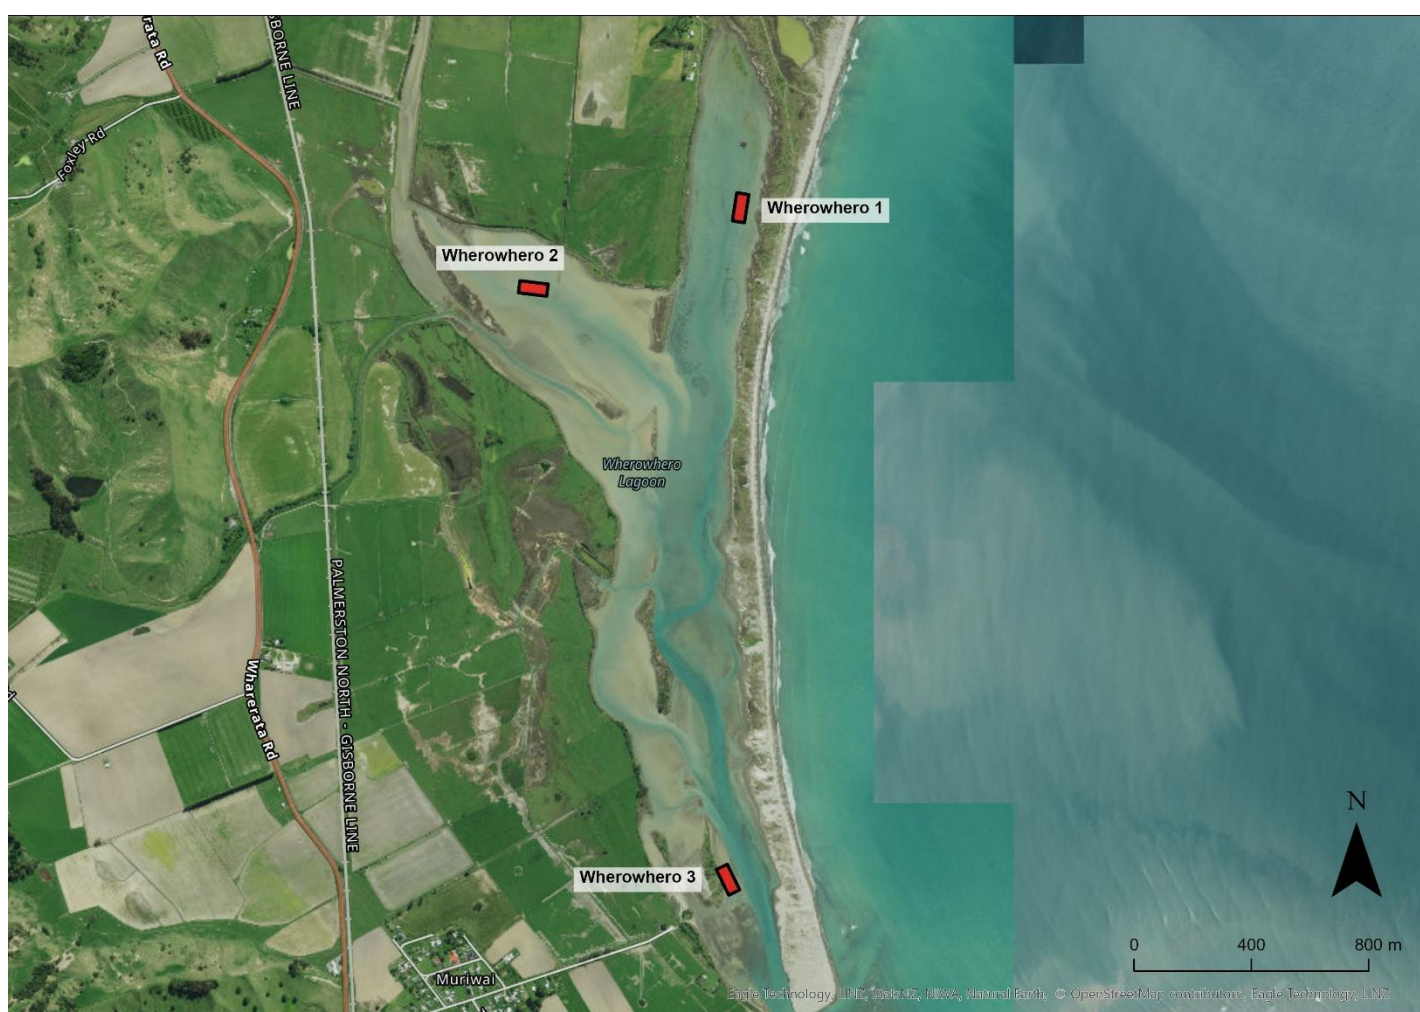
Figure 3. Map of Te Wherowhero Lagoon.

Three representative survey sites were established at Te Wherowhero Lagoon at suitable benthic habitats (Figure 3). Wherowhero 1 was located at the northern/upper end of the lagoon, Wherowhero 2 was located in the north-western/central zone of the lagoon near the Pākōwhai Stream inlet, and Wherowhero 3 was positioned at the southern end of the lagoon closer to the saltwater inlet. Each survey site measured 60m x 30m and was split into nine plots, each measuring 20m x 10m, to achieve nine replicates per location. The long edge of each site was positioned parallel to the water's edge. Site GPS coordinates can be found in Appendix 1.

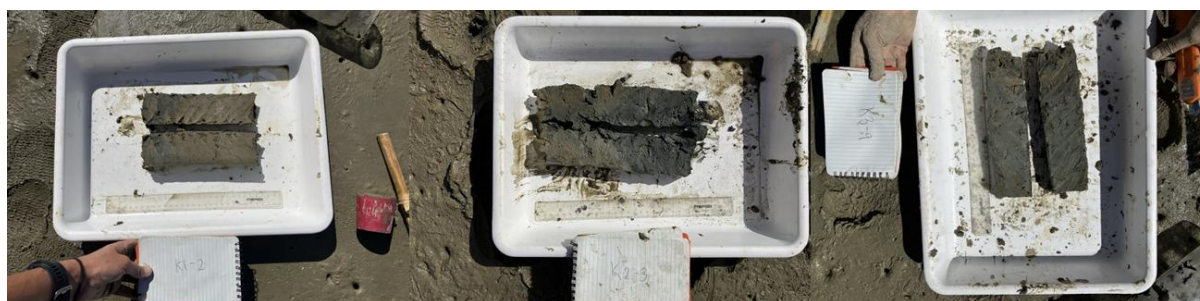
Kaitawa Estuary had no sulphide odours in any of the sediment core samples. The Kaitawa 1 cores (Figure 5), located nearest to the estuary mouth, were predominantly composed of brown, orange and grey clay with a fine, soft surface layer. In contrast, the Kaitawa 2 cores (Figure 5) had a coarser texture, consisting mainly of sand and fine silt with grey and brown tones. One of these cores featured an RPD layer at a depth of 200mm (Figure 6). Kaitawa 3 cores (Figure 5), taken from the upper estuary margin, were mainly dense brown and grey clay with some samples showing a thin layer of fine sediment on the surface.

Figure 5. Sediment cores from Kaitawa Estuary. Left is an example from Kaitawa 1, middle is an example from Kaitawa 2, and right is an example from Kaitawa 3.

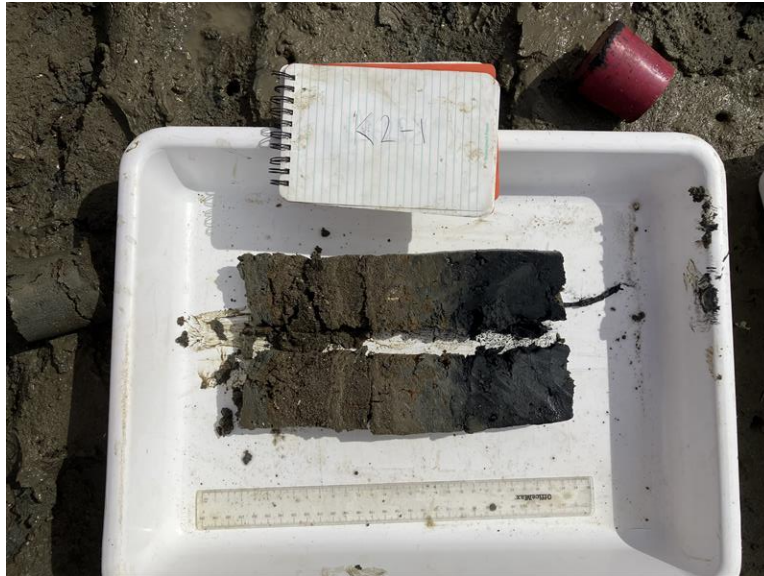
Figure 6. Kaitawa 2 sediment core displaying an RPD layer.

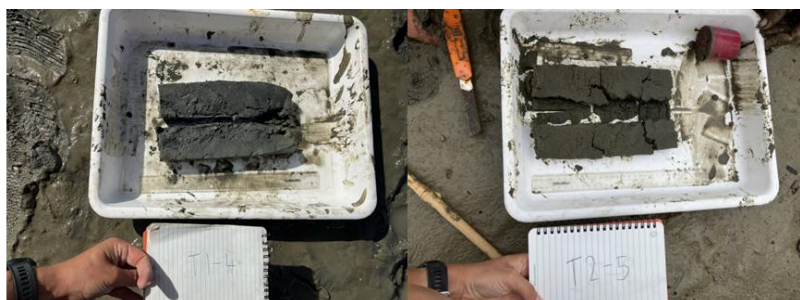
Tūranganui 1 had core samples that exhibited sulphide odours. Tūranganui 1 sediment cores consisted of fine, waterlogged silt with a gritty texture due to decomposed shell material. The Tūranganui 2 cores were composed of granulated, sandy sediment with grey and brown hues. No distinct RPD was observed at either site. Example cores are shown in Figure 13.

Figure 13. Sediment core examples from Tūranganui Estuary. Tūranganui 1 on the left and Tūranganui 2 on the right.

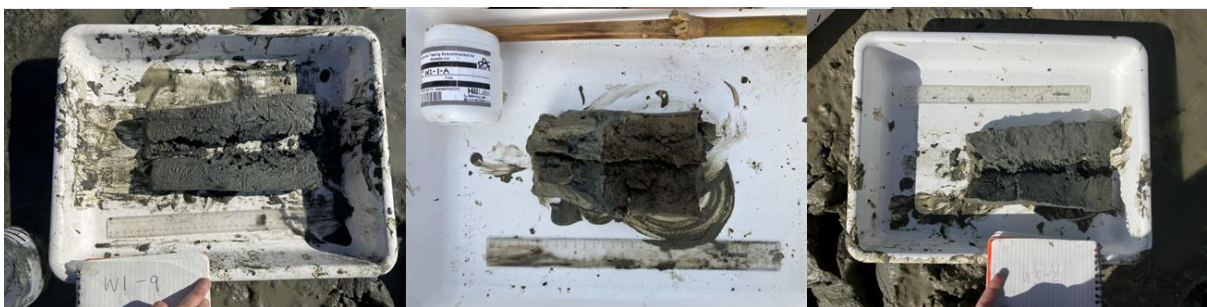
A strong sulphide odour was detected at Wherowhero 3. This is generally a sign of organically enriched and highly anoxic (oxygen deficit) sediment which may have been due to decomposition of woody debris which was abundant at this site. Wherowhero 3, located closest to the lagoon mouth, featured cores primarily composed of a fine grey and brown silt layer in the upper <100mm, followed by a grey and brown clay and silt layer extending to around 150mm depth, beneath which lay a grey coarse sand layer. The other two Te Wherowhero Lagoon sites had surface layers of fine silt, transitioning to sand, silt, clay and then coarser sand at greater depths. Example core samples are provided in Figure 18.

Figure 18. Example sediment cores from Te Wherowhero Lagoon. Left is Wherowhero 1, middle is Wherowhero 2, and right is Wherowhero 3.
