# Future-proofing erosion-prone hill country against soil degradation and loss during large storm events: have past lessons been heeded?

Mike Marden\*

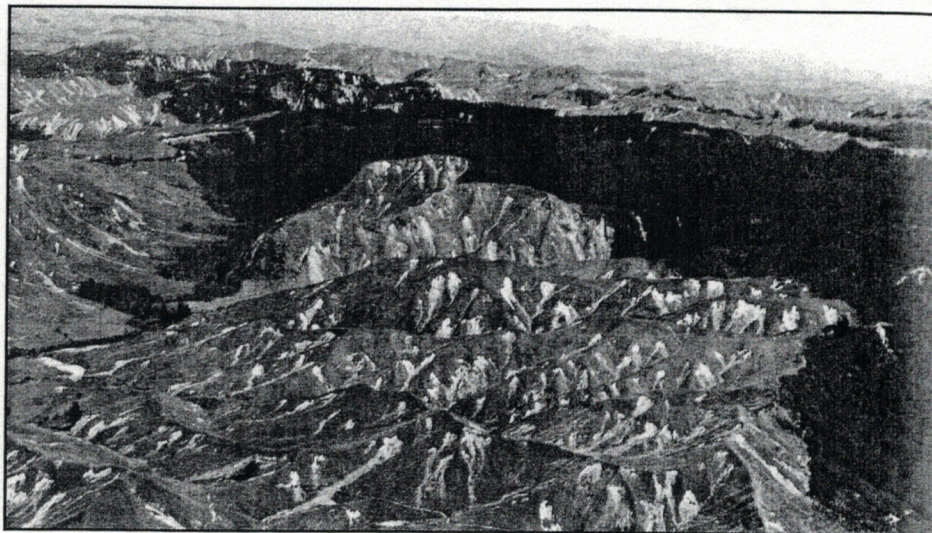
Fig. 1: Contrasting densities of shallow landslides initiated during Cyclone Bola (1988) in native forest and pasture. Photograph courtesy of Don Miller.

These figures show that a forest cover affords considerable protection against the initiation of landslides and are consistent with process-based research showing little difference in the magnitude of interception loss, as a percentage of rainfall, across different, closed-canopy vegetation communities (Rowe *et al.* 1999). Soils under a forest cover will therefore be less prone to rainfall-induced landslides than similar soils under pasture and other vegetation types with an open or partial canopy, including young stands of pines and scattered, regenerating scrub. Fig. 1 shows contrasting landslide densities on pasture and closed-canopy forest (indigenous) following Cyclone Bola.
