Waimatā River Flooding

Slash Debris Summary

February 2023

On 22nd February 2023 permanent photo points were established along the Waimatā River to document the tree species debris which were translocated and deposited within the recent (February 13th – 15th 2023) cyclone which passed through the east coast, known as ‘Cyclone Gabrielle’.

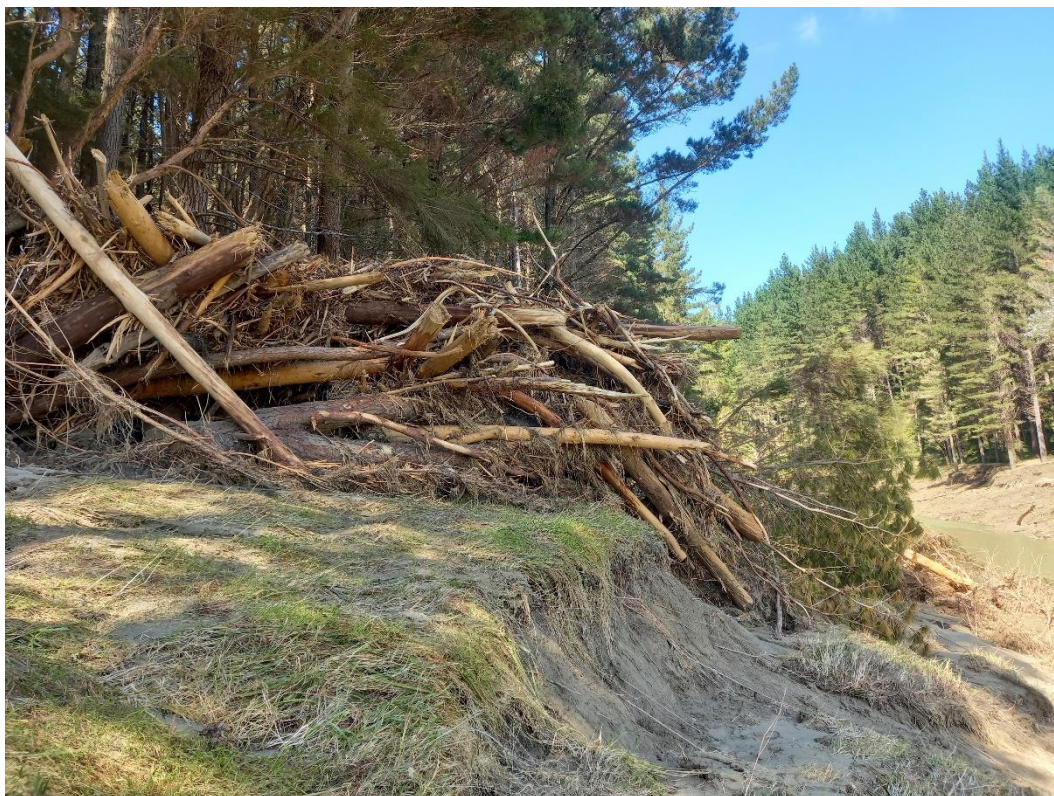
WR1 – Site one on the Waimatā River, around the 10km mark of Waimatā Valley Road. A large build-up of primarily pine debris is on the true left of the river.

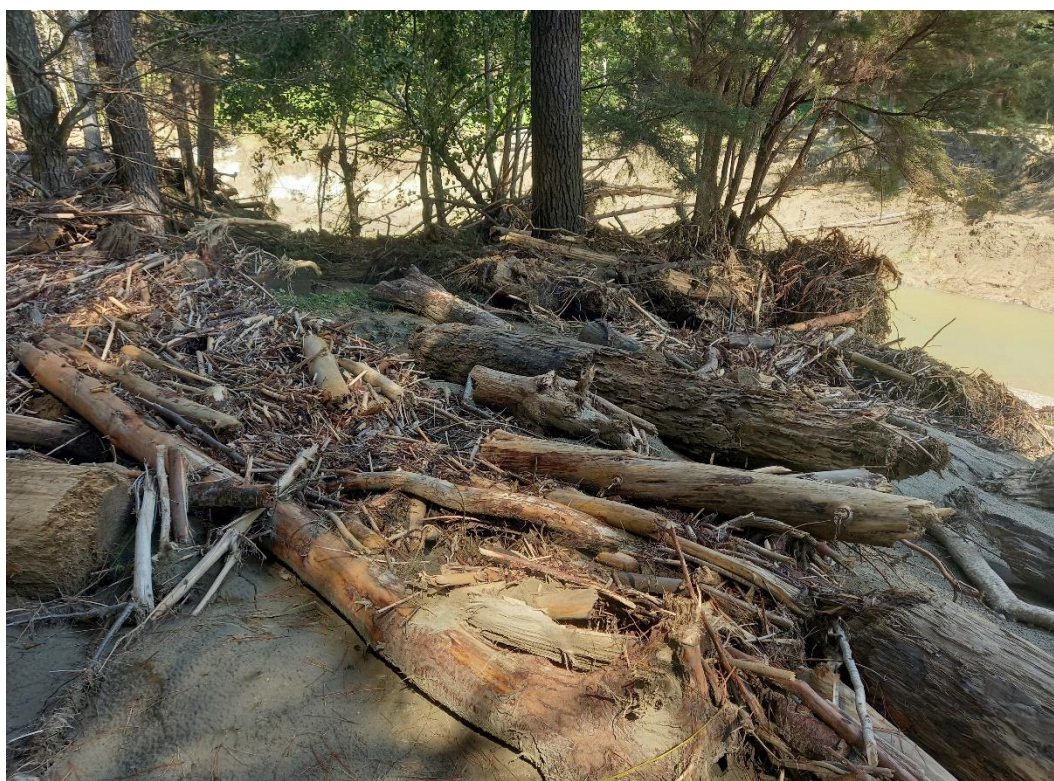
WR2 – Site two on the Waimatā River, east of the 10km mark of the Waimatā Valley Road. Pine debris has been caught in kānuka and another *Pinus radiata* plantation on the true left bank of the river.

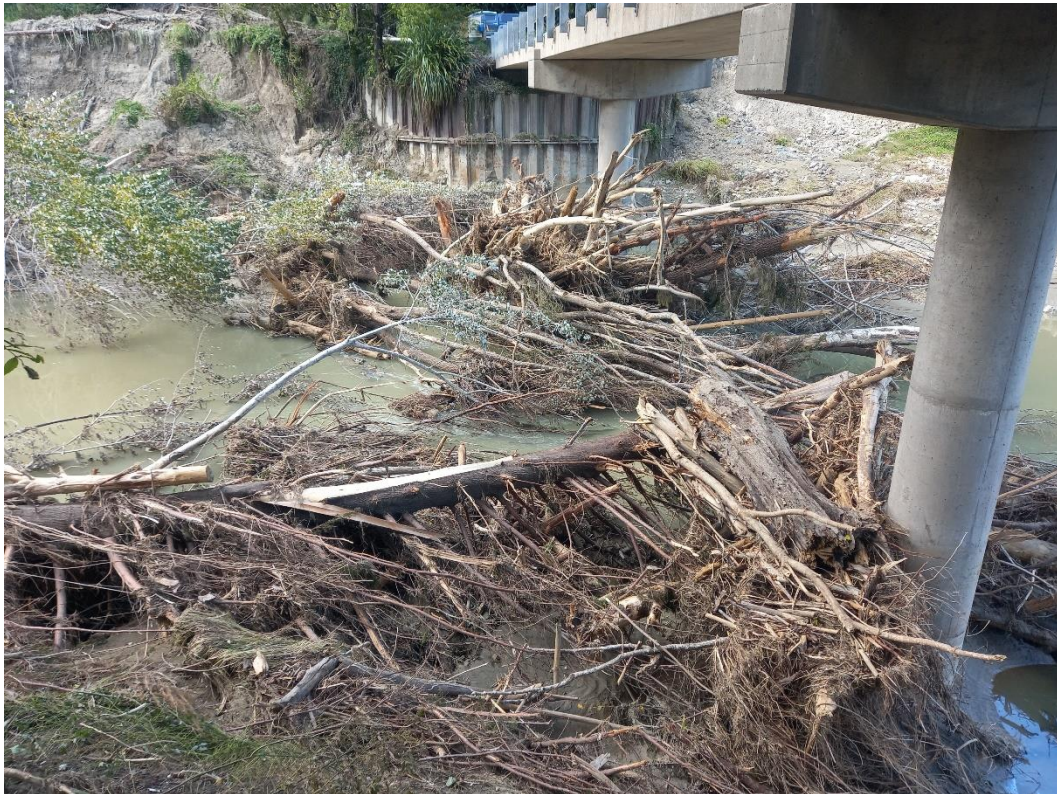
WR3 – Watson's Bridge, Linburn Road over the Waimatā River. A mix of pine, one macrocarpa and silver poplar has collected beneath the bridge.

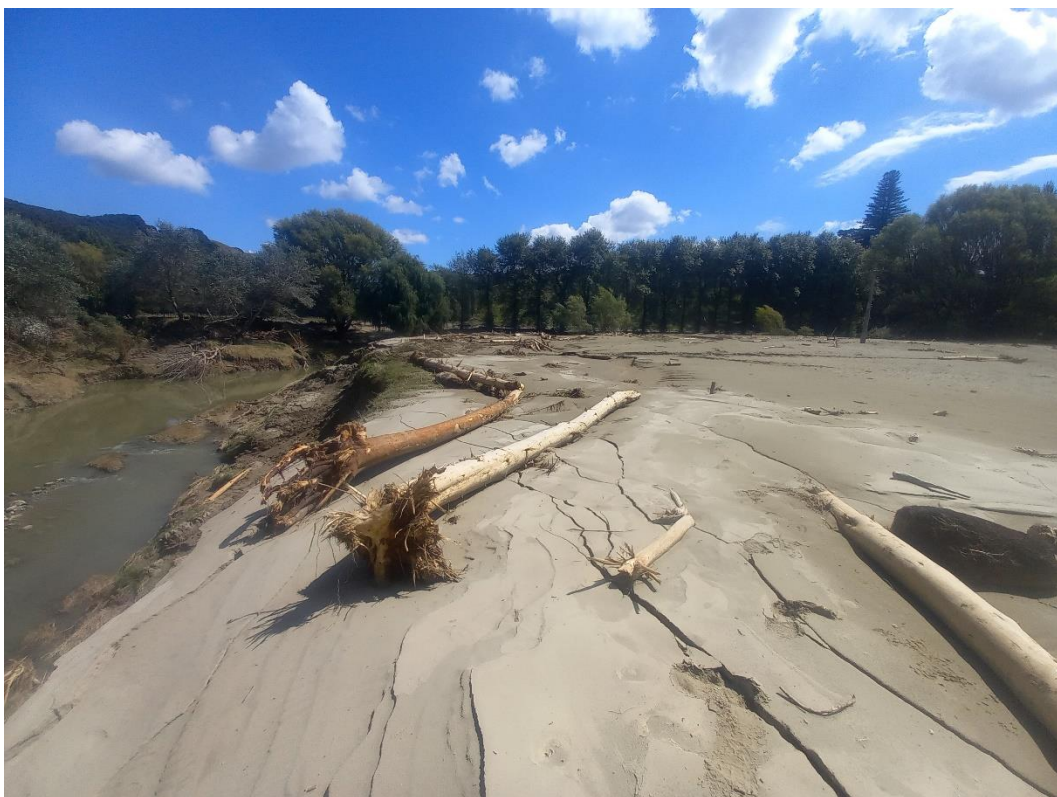
WR4 – Waimiro Station, Waimatā Valley. A paddock on the true left of the river has been completely covered in a thick layer of silt with identifiable parts of pine scattered throughout.

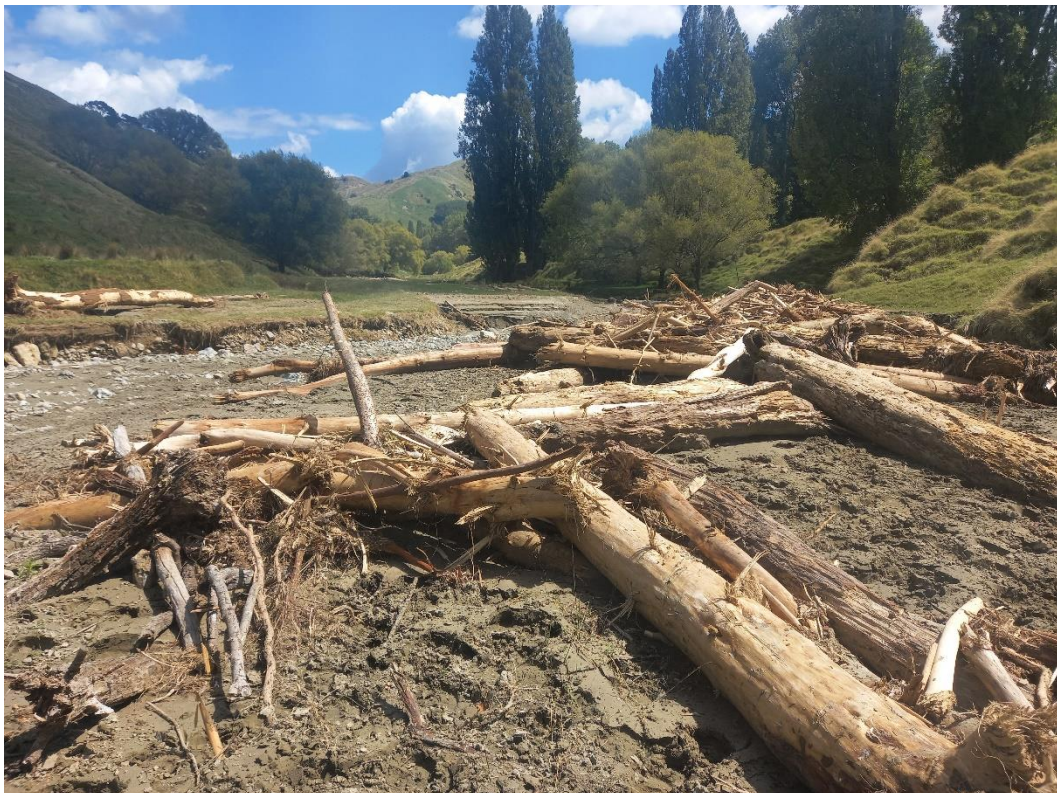
WR6 – Monowai Station, Waimatā tributary stream. Pine waste has mostly built up on the true left with some scattered on the true right.

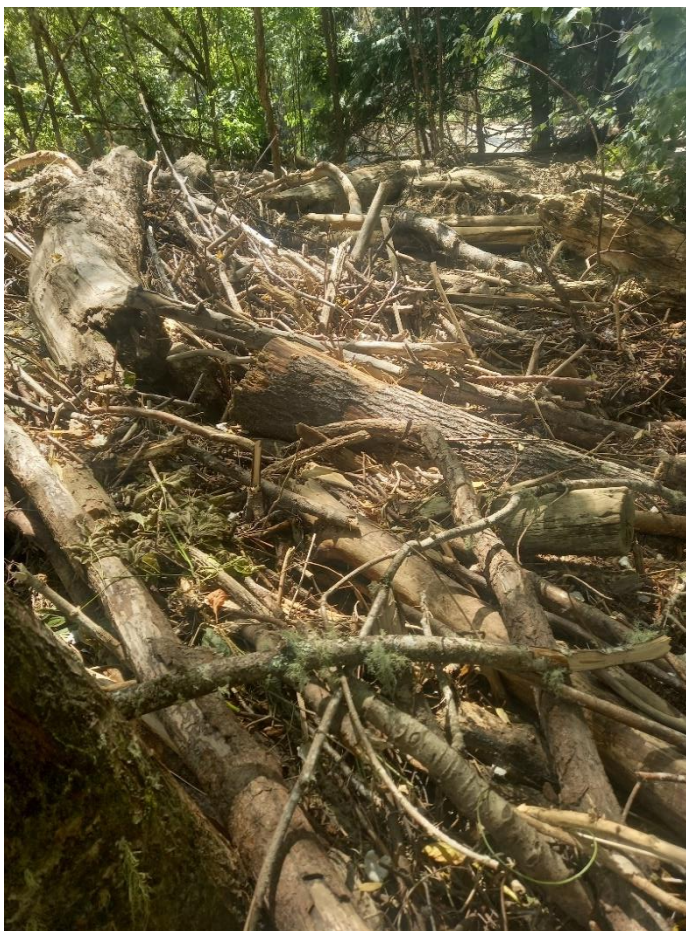
WR7 – Monowai Station, confluence of tributary and Waimatā rivers. Debris piled up on island in between, extending out from a paddock inundated by silt.

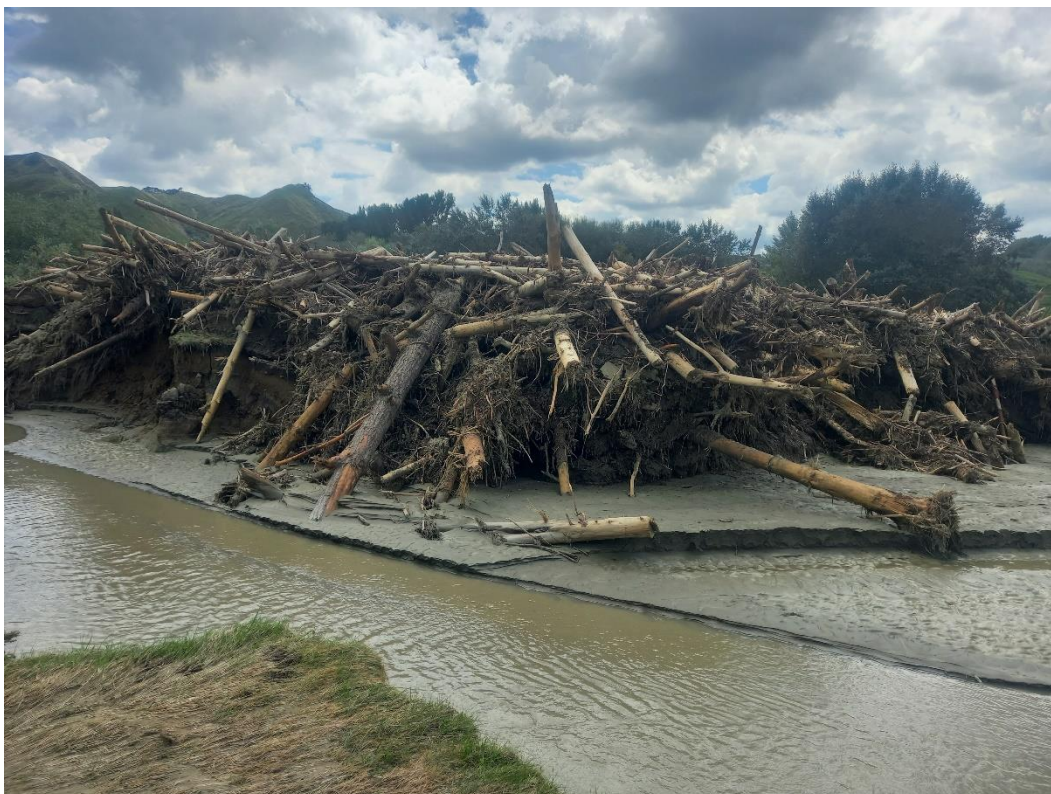
WR8 – Waimatā Valley 18km culvert. Mainly on true left bank of main river channel, downstream a few metres (WR9) piles are on both banks are c.3 metres in height.

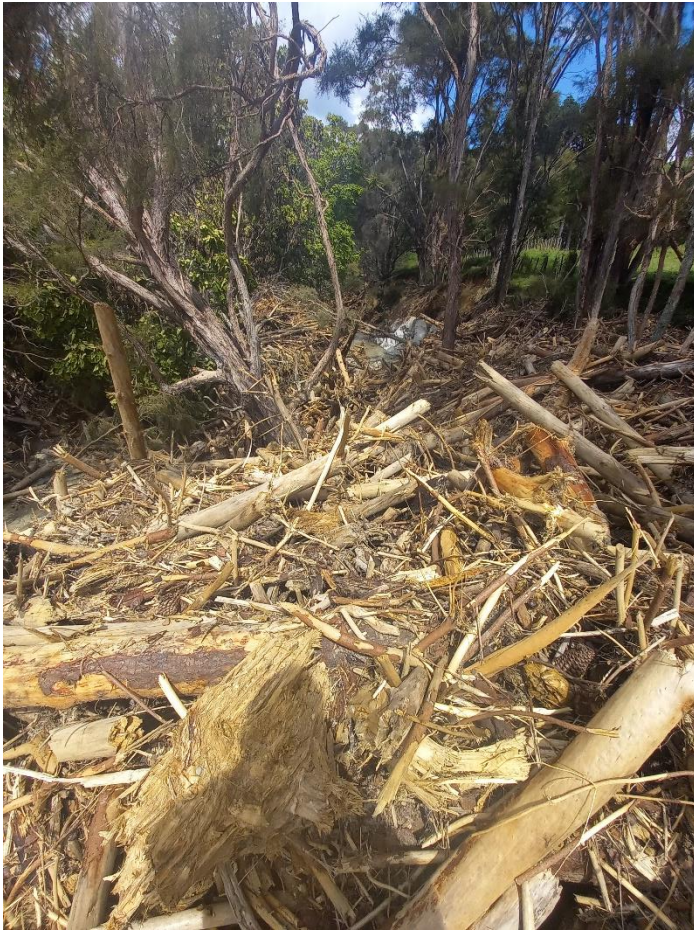
WR9 – Waimatā River, downstream from 18km mark culvert – 2+ metres deep in slash.

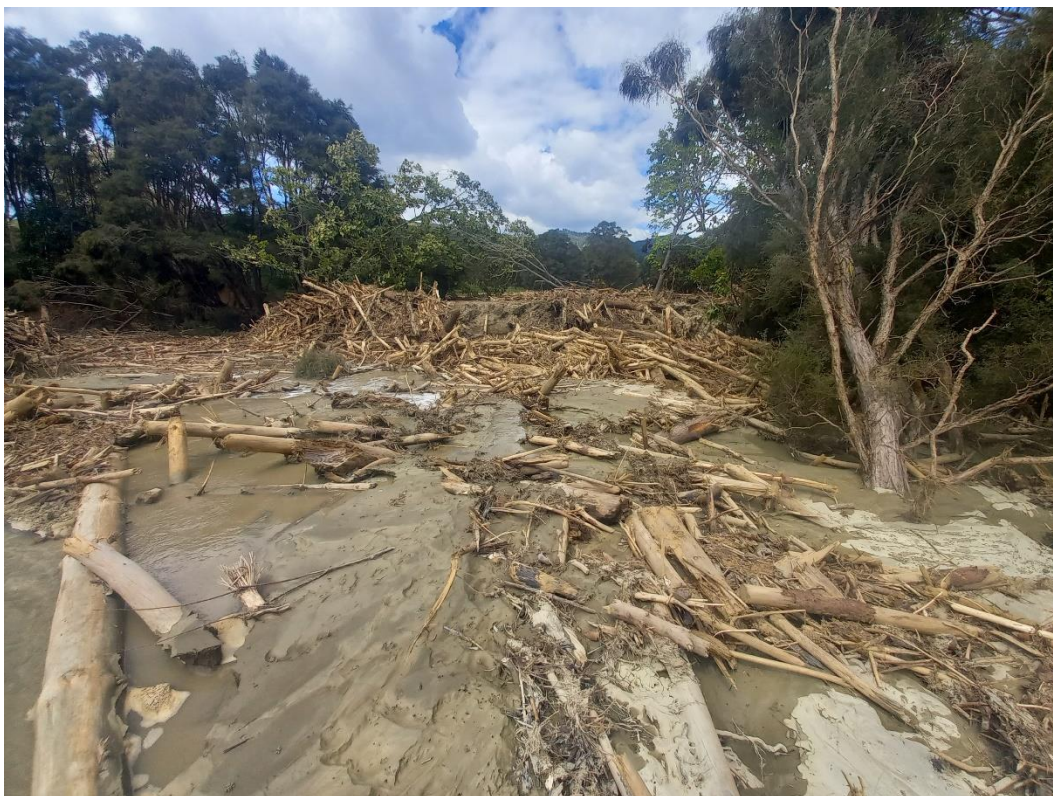
Accumulation of pine debris in the Waimatā River, downstream of the 18km culvert which became blocked during the cyclone.

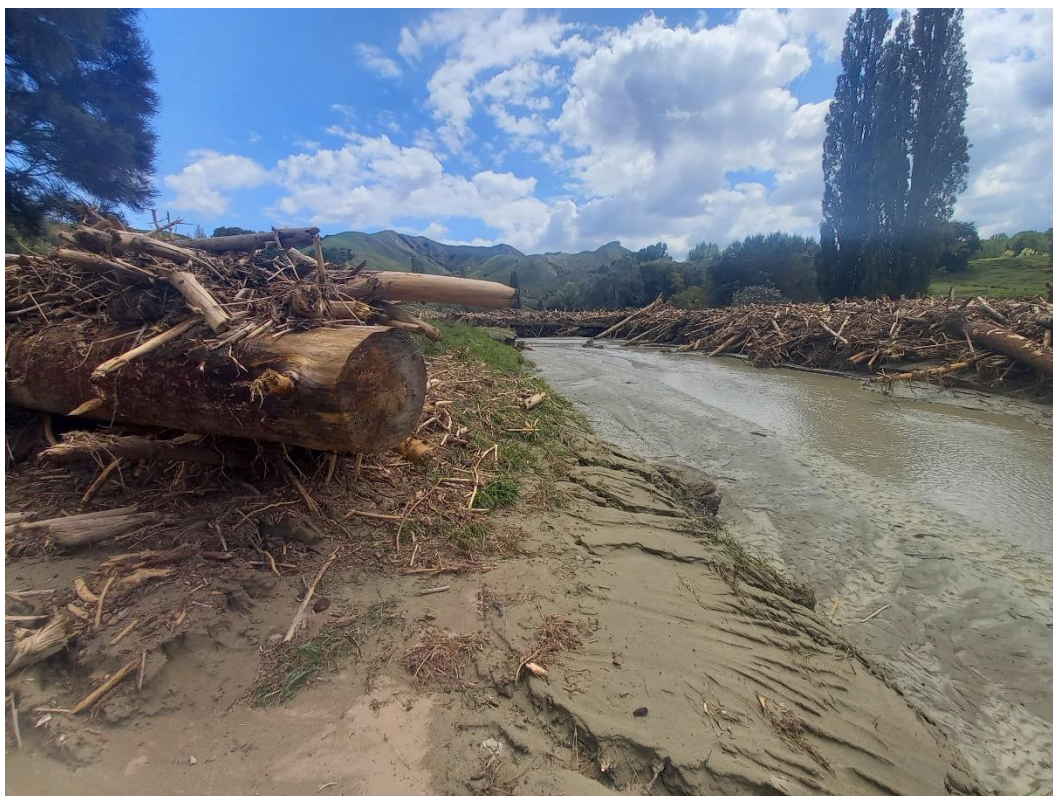
An example of where the debris has travelled from a pine harvest forest, where the tree has been cut is obvious. Slash to a mean depth of c.3m on right of photo.

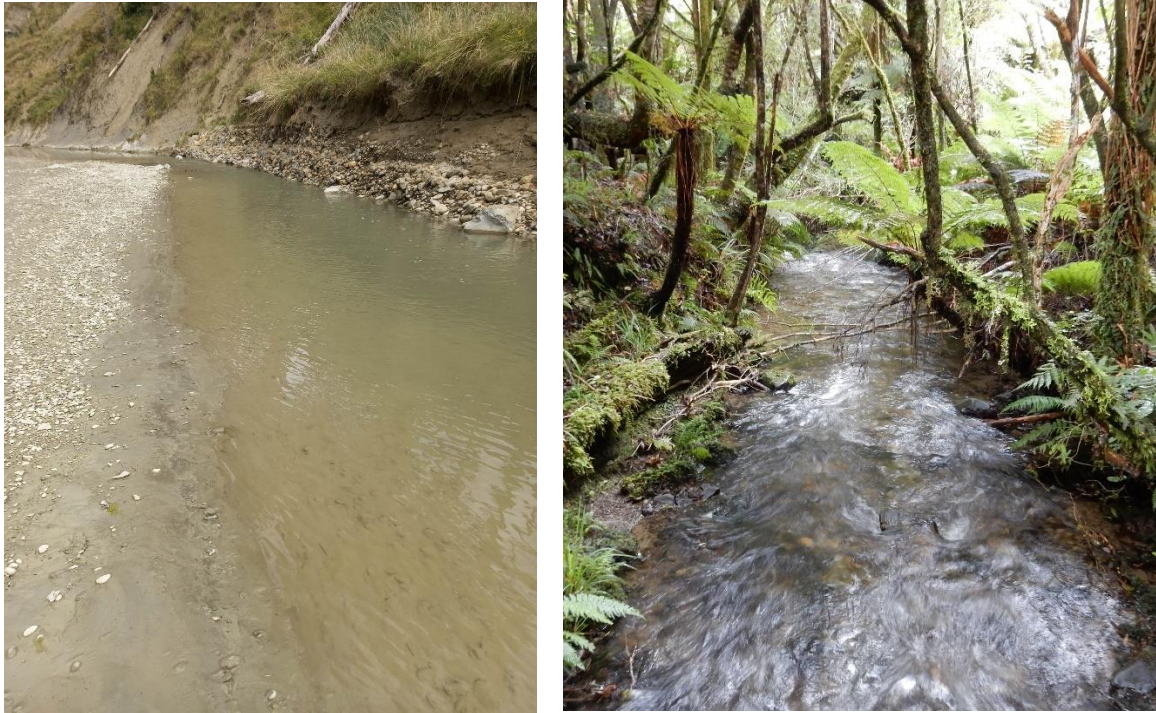
Above Left – An upper tributary of the Waipaoa River 3 weeks after Cyclone Hale showing a high sediment loading. Macro-invertebrate densities were extremely low due to loss of habitat and dissolved oxygen available. After observing this stream since 2005 the level of silt deposited within this stream has increased markedly since pine harvesting was commenced. Prior to harvesting this stream contained a cobble-shingle bed load. This site contains endemic and endangered long-tailed bat. Bat pass rates at this site during 2022 were recorded at 4.62 bat passes/hr using AR4 spectral bat detectors. Only scattered native vegetation is found at this site the site is dominated by grasses and mixed age class radiata production forest. A maximum of only 5 native bird species were recorded per data point during five-minute bird counts during 2022 (Huanui Forest Ecological Assessment August – Ecoworks NZ Ltd. September 2022).

Above Right – An upper tributary of the Motu River stream also 3 weeks post Cyclone Hale. Native vegetation shades, buffers and protects this stream. Native forest of mixed age classes produces a maximum protection effect for this freshwater habitat. Native bat pass rates at this site are 9.82 passes per hour using the same monitoring methodology as above. Macro-invertebrate fauna is abundant, freshwater fish species including long-finned eel are abundant and native bird species diversity numbers as high as 11 species per 5 minute bird count data point.
